REVIEW OF THE MARYLAND TRANSPORTATION AUTHORITY'S BRIDGE AND TUNNEL INSPECTION PRACTICES

Final Report

Of the Bridge and Tunnel Inspection Peer Review Panel

June 1, 2009

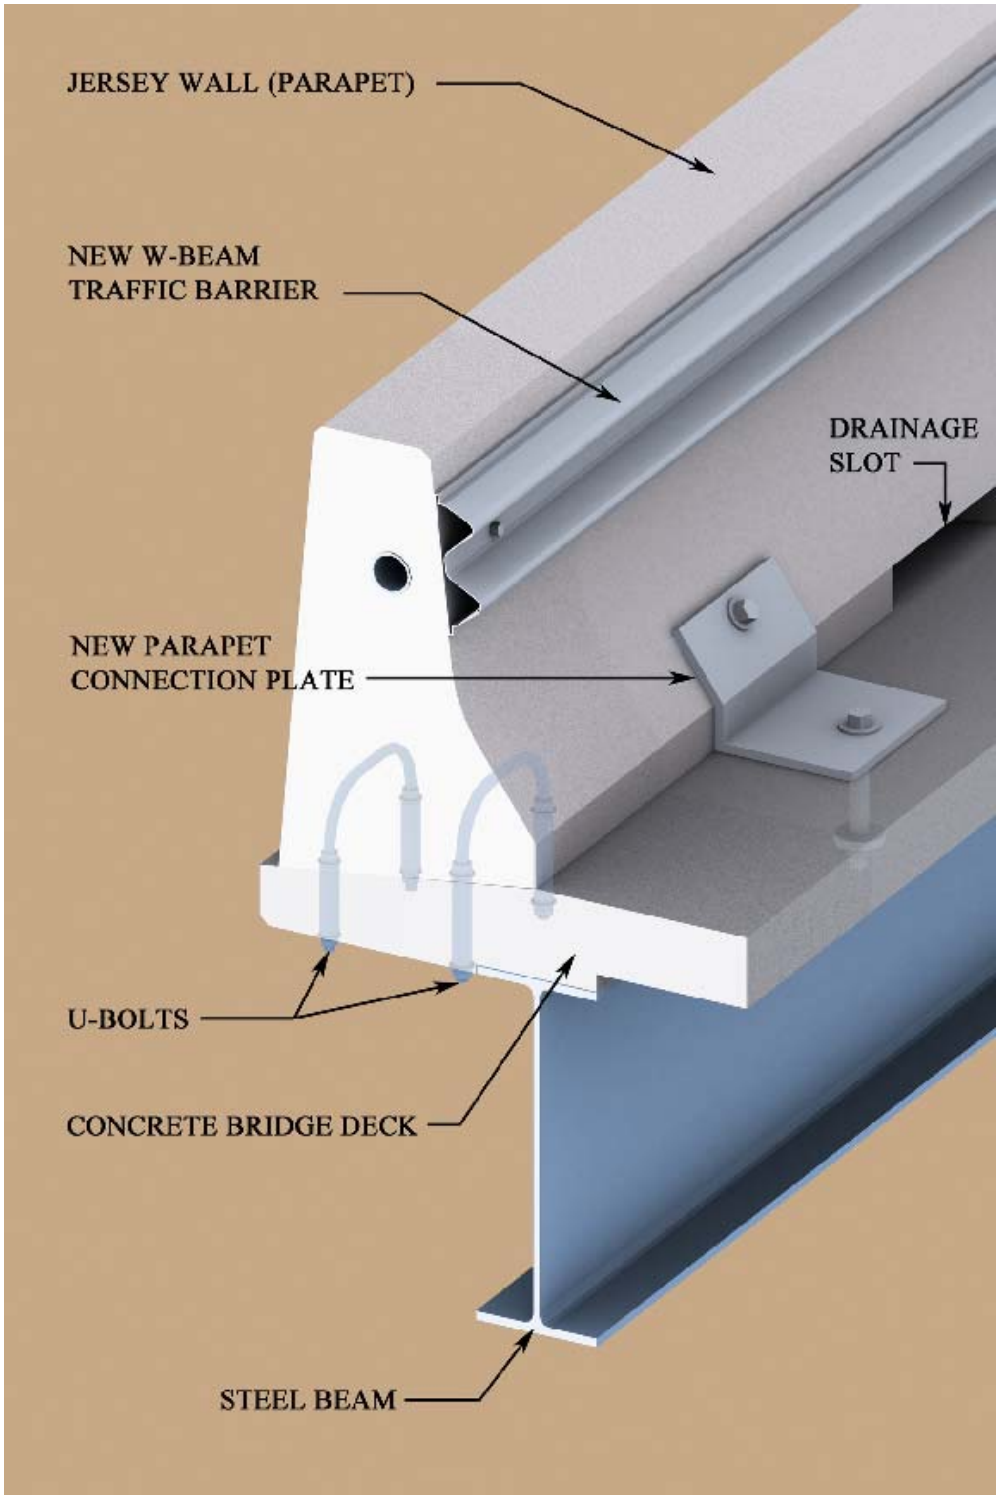
Figure 3.1 Retrofits Installed in 2008 on Bay Bridge Jersey Barrier Railing

The 13-foot section of Jersey barrier railing knocked into the bay on August 10 was recovered by MdTA and the Panel had the opportunity to conduct a visual inspection of its current condition. This inspection revealed two possible problems: voids in the Jersey barrier railing, and corrosion and embedment length of the steel bolts that connected the railing to the deck.

With respect to the first problem, voids are small areas where the concrete did not fully fill the volume in the Jersey barrier railing, creating a path for water to infiltrate. These voids were likely created when the railing was originally constructed. Since voids are in the interior of the railing they cannot be detected by visual inspection. In this case they were revealed when the impact displaced the two railing sections.

With respect to the second problem, the corroded bolts had weakened the connection between the railing and the deck to which it was attached. As noted earlier, the railing was not designed to withstand a heavy truck at normal speeds hitting it at a 40 degree angle, and thus the corrosion is not believed to be a significant factor in this crash. Nevertheless the corrosion is of concern since it had not been detected until exposed after the crash. MdTA inspectors had not found this corrosion previously nor would close visual inspection by a qualified inspector have revealed it since the bolts cannot be seen at the interface between the railing and the deck.

Since the August 10 crash, repairs and improvements have been made to the railing, considerably strengthening it. These include bolting steel guardrails on the face of the railing and bolting steel “L” braces at close intervals, thus strengthening the connections between the railing and the deck. The guardrails provide longitudinal continuity along the railing and the “L” braces provide additional connection-to-deck strength. (Figure 3.1) The total length of the railing to be retrofitted on the Bay Bridge is about 8,100 feet out of a total railing length of 42,572 feet, or roughly 20 percent of the total railing used on the bridge.

These changes have strengthened the railings such that they are stronger than when originally constructed. They meet the equivalent of the TL-2 Standard as a minimum.[15]

In the period following the August 10 crash, MdTA has both strengthened the railings themselves and how they are attached to the bridge. These improvements come from using the bolted guardrails and “L” braces as previously described. These recent improvements mitigate the safety problems posed by the concrete voids and bolt corrosion but may influence the ability of the railing to redirect traffic as it is designed to do. MdTA plans to replace the temporary retrofitted railing as soon as possible.
