Maryland
Transportation
Authority

Evaluation of Additional Safety Measures
at the William Preston Lane Jr. Memorial Bridge

FINAL REPORT

November 2012

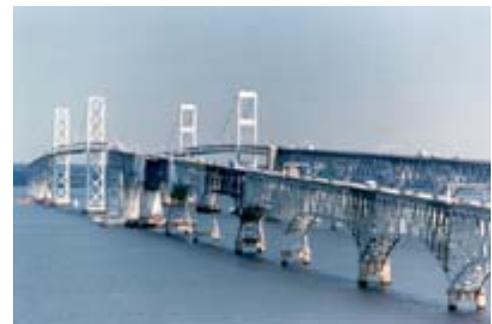
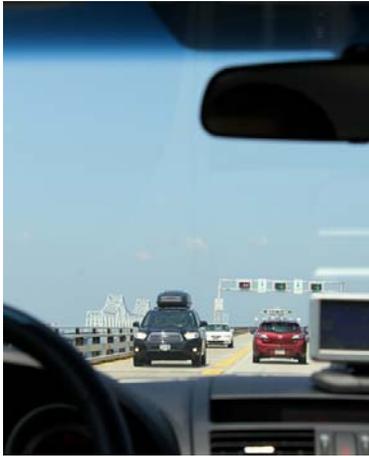
Westbound Bay Bridge in 2-way
Photo Courtesy of
Misty Garrick Miller

The westbound bridge includes a reversible lane, which permits traffic to travel either westbound or eastbound, depending on the heavy directional traffic flows during the morning and evening peak hours, especially during summer weekends, holidays and events.

The reversible lane is the left lane of the westbound bridge (lane 3) and is denoted by reversible pavement markings (a set of two, dashed yellow lines used as lane lines), and by overhead lane use control signs which display either a green “down arrow” to inform motorists they can enter the lane and are traveling in the correct direction, or a red “X” to inform motorists not to enter the lane. The reversible lane is regulated by a crossover or transition area at each end of the bridge. The crossover is used exclusively for the reversible lane at each end of the bridge and permits one side of the lane to be “coned off” to discourage motorists in one direction

The westbound bridge carries two (2) 13 feet wide curb lanes and a single 12 feet wide center lane. There are no shoulders on the bridge. There is no positive separation, or physical barrier between traffic, between vehicles traveling opposite directions on the span. Due to growth in traffic, the reversible lane has been used with increasing frequency. Reversible operation has increased over the past ten (10) years in order to serve peak traffic demands and perform construction on the Bridge.

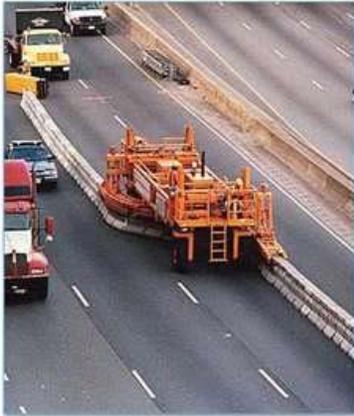
Moveable Barrier System Photo
Courtesy of FHWA

The fact that the system is movable created some distinct advantages over other options. The system could be moved if necessary, a factor that no other option could provide while also creating positive separation. The barrier could also be moved to maintain positive separation between one westbound lane and two eastbound lanes if the need to reverse the center westbound lane arose.

Reduced Lane Widths - The westbound bridge carries a single 12 foot center lane with two 13 foot outside lanes and no shoulders. Most of the moveable barrier systems that MDTA has found range from 1.5 to 2 feet in width. If a barrier is placed on the bridge between the left and center lanes on the westbound span, the lane width for each of these lanes will be reduced by 1 foot

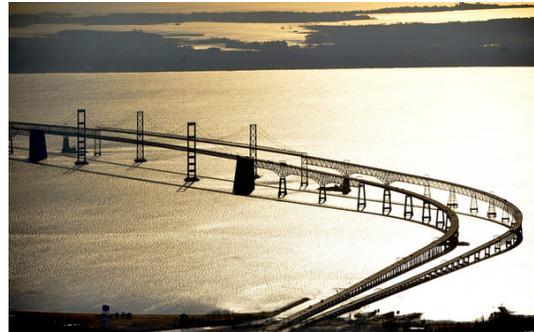
Sight Distance - The height of concrete barrier is 32 inches for existing installations and 42 inches for new installations. The 42 inch high barrier is preferred on new installations because it provides improved crash test performance and is rated to Test Level 5 (TL-5) while the 32 inch high barrier is only rated to Test Level 4 (TL-4) according to the AASHTO Roadside Design Guide. Stopping sight distance, the distance required to see a vehicle, react and stop prior to hitting the vehicle, is based on seeing the tail lights of the vehicle you are approaching. The generally accepted height of tail lights based on the AASHTO Green Book is 20 inches. A barrier when combined with the existing horizontal and vertical curves on the bridge will obstruct driver visibility of vehicles ahead thereby reducing sight distance. This will make it more difficult for a motorist to see a stopped vehicle in time to stop or slow down.

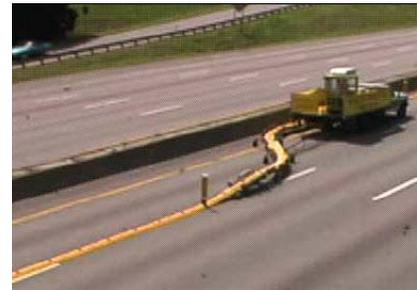
Photo Courtesy of Qwick Kurb[®], INC

Several options could be considered to create a buffer space between the reversible lane and the westbound center lane (lanes 2 and 3). One such system is designed by Qwick Kurb[®] Inc. which features flexible markers or bollards mounted to a base. The system features continuous linked bases that can be anchored to the bridge deck, left in place without being bolted to the deck and are capable of being moved by a machine. While originally designed for work zones, Qwick

Limited Space Requirements – The system has a width of 11.5 inches which would fit within the space taken by the current lane markers on the Bay Bridge. If the system was stored on the shoulder of lane three, the lane width would still exceed 11 feet.

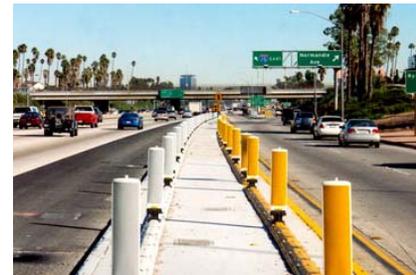
Photo Courtesy of
Qwick Kurb[®], INC

Fewer Impacts on Incident Management – The “Qwick Kurb[®]” type systems are simple to walk back and forth between. At ten pounds per foot, the system could easily be moved by maintenance crews or first responders if necessary to gain access to an incident scene. The system also allows vehicles to easily drive over the delineator posts and linear curbing without causing damage to vehicle or delineator posts if required during incidents.
